NATIONAL TRANSPORTATION SAFETY BOARD

AIRCRAFT ACCIDENT REPORT

UNCONTROLLED IMPACT WITH TERRAIN
FINE AIRLINES FLIGHT 101
DOUGLAS DC-8-61, N27UA
MIAMI, FLORIDA
AUGUST 7, 1997

**FINE AIRLINES FLIGHT 101
DOUGLAS DC-8-61, N27UA
MIAMI, FLORIDA
AUGUST 7, 1997**

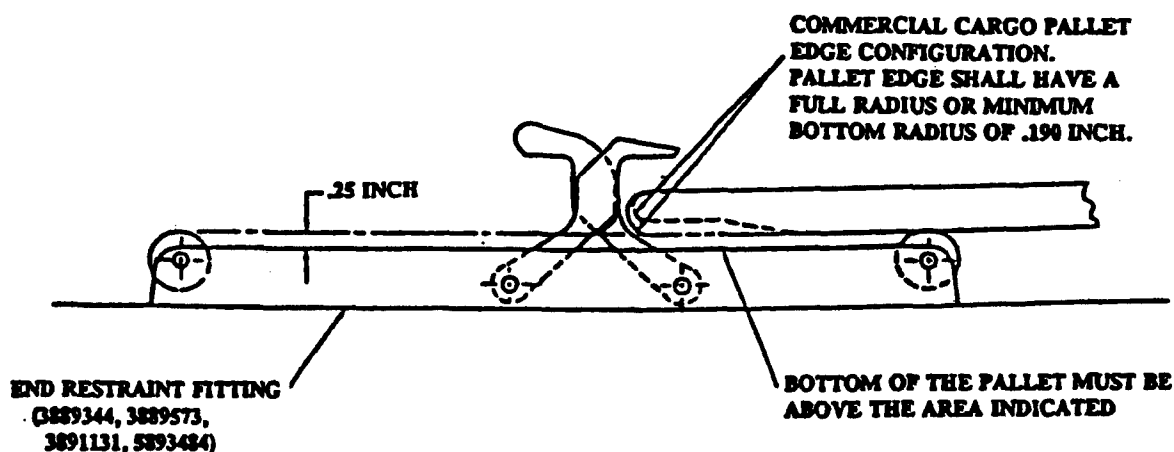
6. Pallet Edge Configuration Fittings Required

All commercial pallets used in cargo operations must conform to the restrictions shown in Figure 3, below. Specifically, the edges of pallets engaging the pawls of the end restraint fittings must have a full radius or a minimum bottom radius of .190 inch. In no case may the edge of a pallet be so configured that it extends into the shaded area shown in Figure 3.

Figure 2.—Pallet edge configuration requirements.

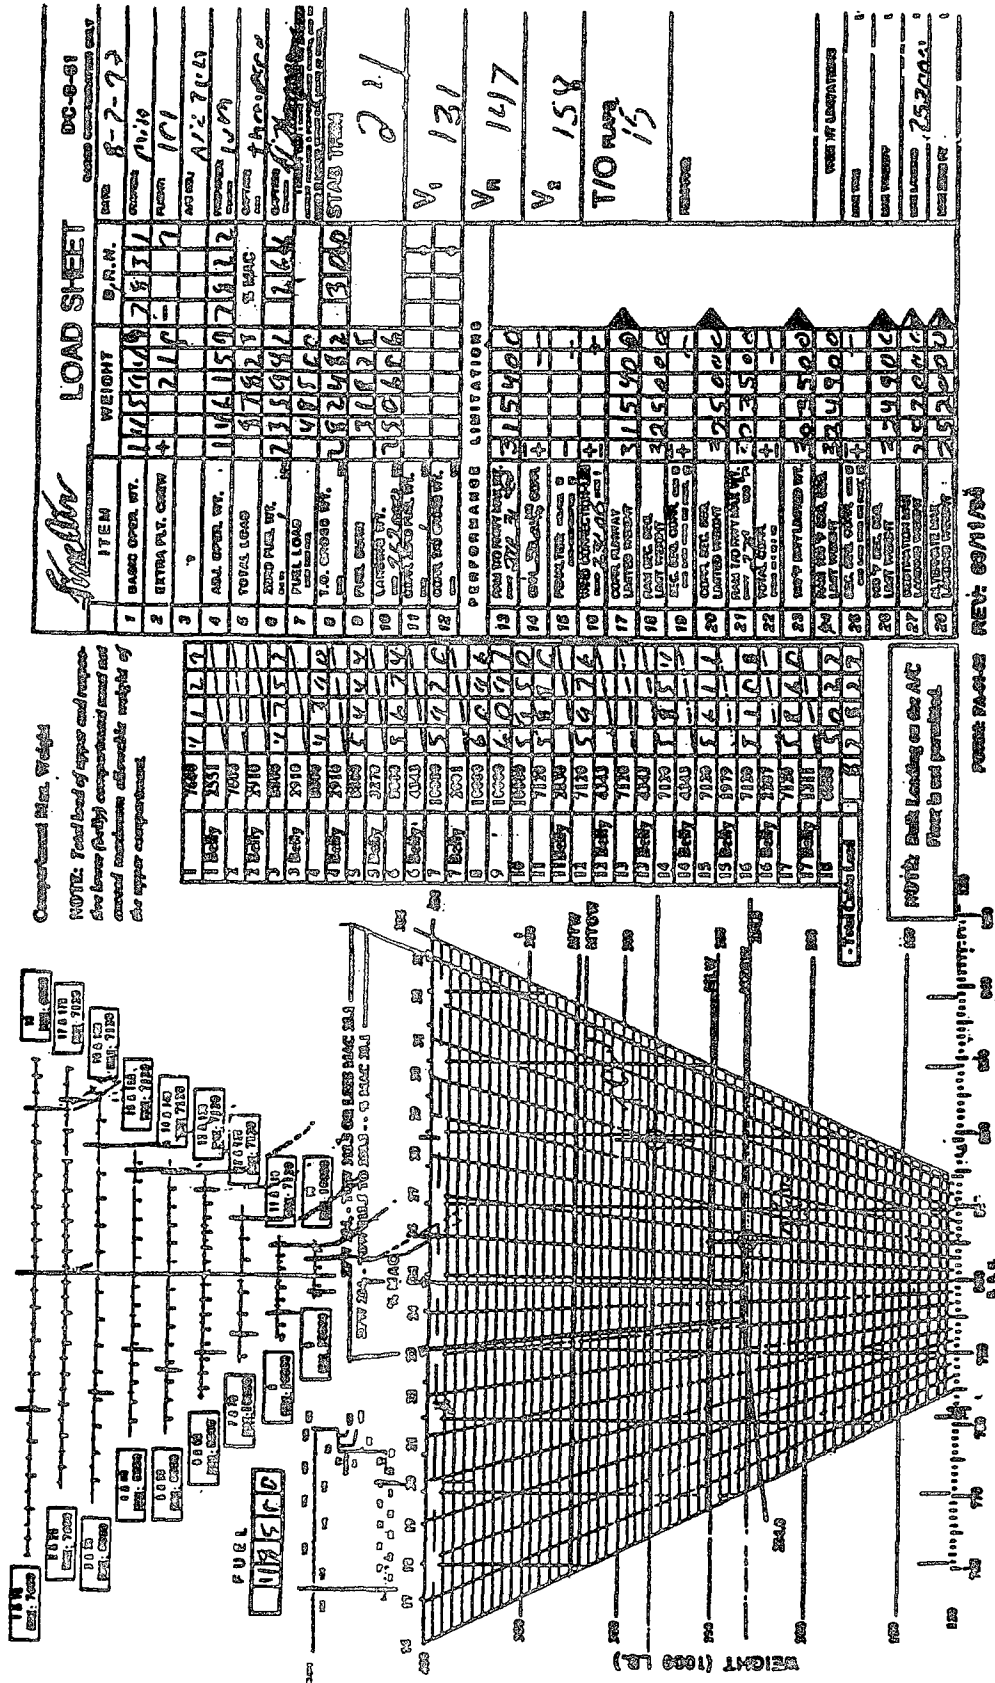
Exhibit 4

ACFT N27UA FLIGHT 101A DATE 8-7-97

POS	DEST	WT	REMARKS	POS	DEST	WT
1	SDQ	4129	REQ	1B		
2		Ø		2B		
3		4757		3B		
4		4390		4B		
5		5444		5B		
6		5674		6B		
7		5970		7B		
8		6076				
9		6097				
10		5950				
11		5890		11B		
12		5976		12B		
13		Ø		13B		
14		5554		14B		
15		5611		15B		
16		5128		16B		
17		5960		17B		
18	SDQ	5027	REQ			
PALLET WT		87923	TOTAL BELLY WEIGHT Ø			
BELLY WT		Ø				
TOTAL WEIGHT (PALLET + BELLY) = 87923
